Contract #: 04-0120F4Cty: SF/ALA Rte: 80 PM: 13.2/13.9File #: 69.28**WELDING INSPECTION REPORT****Resident Engineer:** Pursell, Gary**Address:** 333 Burma Road**City:** Oakland, CA 94607**Report No:** WIR-013240**Date Inspected:** 16-Mar-2010**Project Name:** SAS Superstructure**OSM Arrival Time:** 700**Prime Contractor:** American Bridge/Fluor Enterprises, a JV**OSM Departure Time:** 1900**Contractor:** Zhenhua Port Machinery Company, Ltd (ZPMC), Changxing Island **Location:** Shanghai, China**CWI Name:** Ye Yong Jun**CWI Present:** Yes No**Inspected CWI report:** Yes No N/A**Rod Oven in Use:** Yes No N/A**Electrode to specification:** Yes No N/A**Weld Procedures Followed:** Yes No N/A**Qualified Welders:** Yes No N/A**Verified Joint Fit-up:** Yes No N/A**Approved Drawings:** Yes No N/A**Approved WPS:** Yes No N/A**Delayed / Cancelled:** Yes No N/A**Bridge No:** 34-0006**Component:** Tower Trial Assembly**Summary of Items Observed:**

TOWER TRIAL ASSEMBLY:

WELDING INSPECTION REPORT

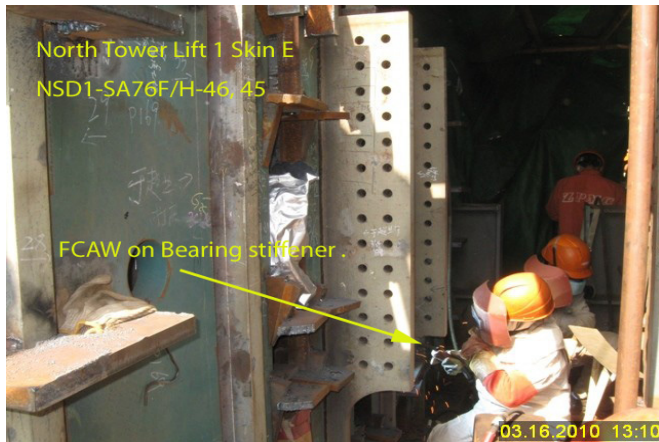
This QA Inspector observed ZPMC qualified welding personnel identified as 053116, 040261. Perform Flux Core Arc Welding (FCAW) on North Tower lift 1 skin E outside, exterior bearing stiffener. Joint identified as NSD1-SA76-F/H-46, 45, ZPMC CWI Identified as Yu Yong Jun, The welding parameters as measured using QC's calibrated instrument appeared to be in general compliance with WPS-B-T-2333-Tc-P4-F. For more information see below attached photo.

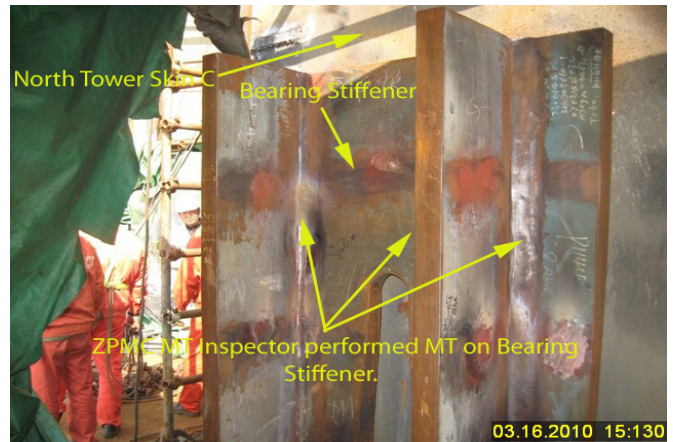
This QA Inspector observed during random Visual inspection, ZPMC Magnetic Particle Testing (MT) Inspector performed MT on bearing stiffener of North Tower lift 1 skin C outside, For more information see below attached photo.
